FULL-SCALE ROOM BURN PATTERN STUDY

ABSTRACT

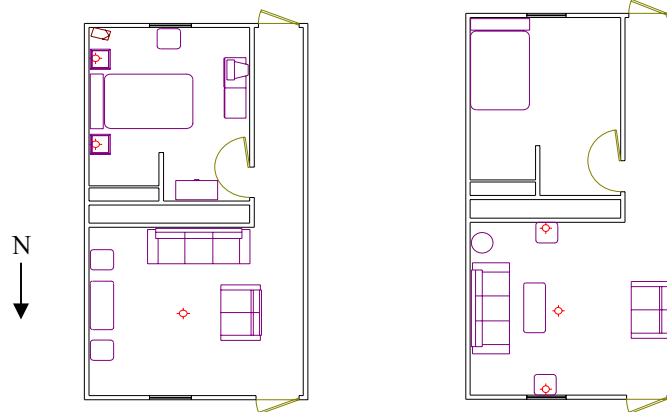
**Figure 3 (left) Furniture Layout for Experiment Set "A" & "C";
Figure 4 (right) furniture layout for Experiment Set "B"**

All experiment sets were ignited by the application of a propane torch to a small plastic bag containing a 4"x4" piece of cotton fabric rag doused with about 4 ml gasoline. Experiment sets "A" and "C" were ignited near the head of the bed on the polyurethane bedspread. Experiment set "B" was ignited near the center of the couch at the base of the vertical cushion.

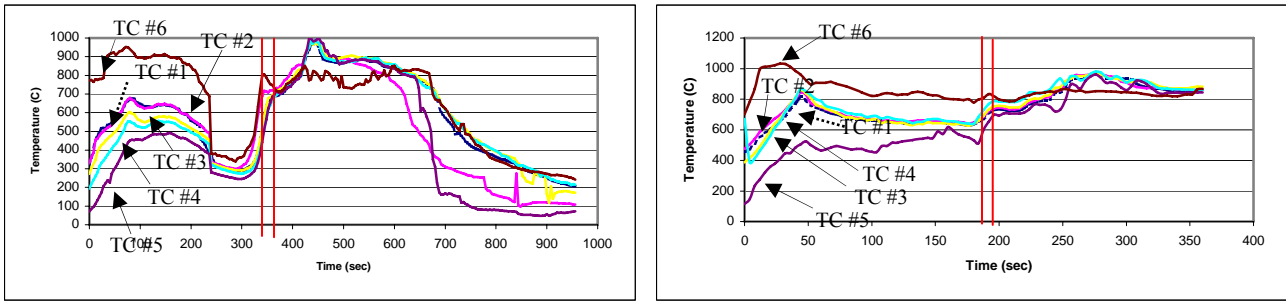
Figures 6 & 7 – Experiment Set “A” Thermocouple Data: (left)-Cell #1 (exp. 1); (right)-Cell #2 (exp. 2)

The temperatures measured by the thermocouple tree located in the bedroom of each experiment are shown in Figures 6 and 7. In cell #1 (experiment #1), the technical indicator of 600°C (1112°F) in the upper layer for flashover was achieved at approximately 330s (seconds). The duration of the post-flashover/fully involved stage of the fire, the time between flashover and suppression, for experiment #1 was 360 s. In cell #2 (experiment #2), the technical indicator for flashover of 600°C (1112°F) in the upper layer was achieved at approximately 190s. The duration of the post-flashover/fully involved stage of the fire for experiment #2 was 200s. Figure 5 illustrates a timeline for each experiment.

The ventilation conditions for the experiments were expected to differ slightly due to the different locations of the rooms within the test burn building. The differences in ventilation are also suggested by the differences in the temperature growth profiles between experiments #1 and #2. In experiment #1, prior flashover, at 230s a substantial uniform decrease in temperature for all thermocouples was recorded. However, in experiment #2, only a minor decrease in temperature was recorded for all thermocouples just prior to flashover.

A possible reason for the dramatic decrease in temperatures seen in experiment #1 and the resulting differences between the two temperature growth profiles is that the fire in experiment #1 became ventilation-controlled early on during the growth of the fire. This resulted in a decrease in temperature and a subsequent increase in time to flashover. Once sufficient oxygen concentrations returned, the fire quickly grew to transition through flashover conditions and into full-room involvement.

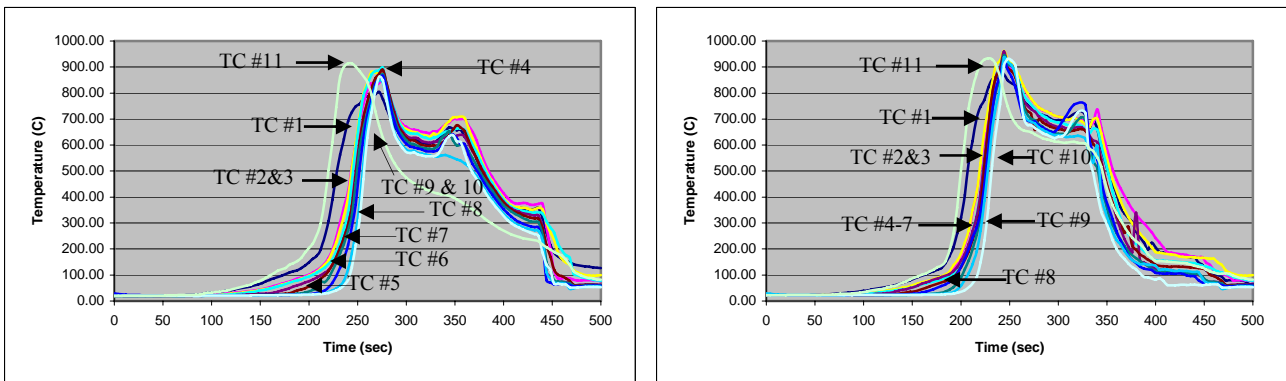
Figures 9 & 10 – Experiment Set “B” Thermocouple Data: (left)-Cell #1 (exp. 3); (right)-Cell #2 (exp. 4)

The temperatures measured by the thermocouple tree located in the living room of each experiment are shown in Figures 9 and 10. In cell #1 (experiment #3) the technical indicator for flashover of 600°C (1112°F) in the upper layer was achieved at approximately 236s (seconds). Also, in experiment #3, the duration of the post-flashover/fully involved stage of the fire was 124s. In cell #2 (experiment #4) the technical indicator for flashover of 600°C (1112°F) in the upper layer was achieved at approximately 212s. Also, in experiment #4, the duration of the post-flashover/fully involved stage of the fire was 120s. The temperature growth profiles from experiments #3 and #4 are almost identical. Figure 8 illustrates a timeline for each experiment.

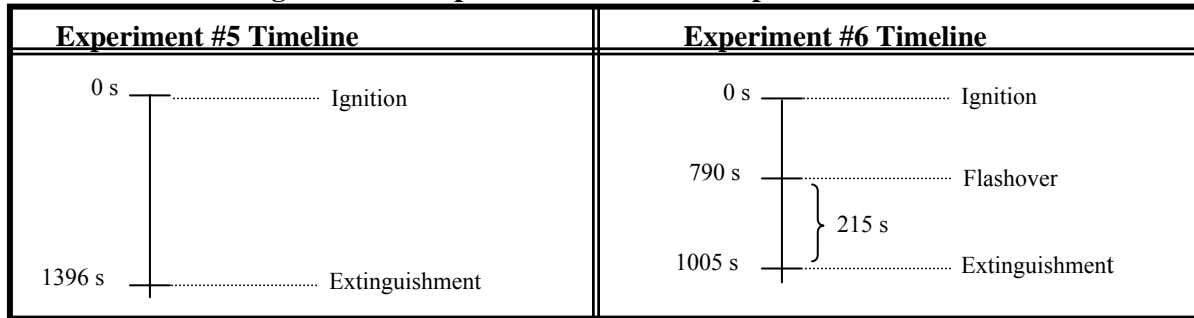
Figure 11 – Comparison of Timelines Experiment Set “C”

room involvement did not occur. This was evident from the radiometer readings (figure 14), as well as the post-fire inspection of the furnishings (Figures 34, 38, 42 and 46). In cell #2 (experiment #6), the technical indicators for flashover of 600°C (1112°F) in the upper layer and radiant flux of 20kW/m² at the floor were achieved at 790s (Figure 15). The duration of the post-flashover/fully involved stage of the fire for experiment #6 was 215s. Figure 11 illustrates a timeline for each experiment.

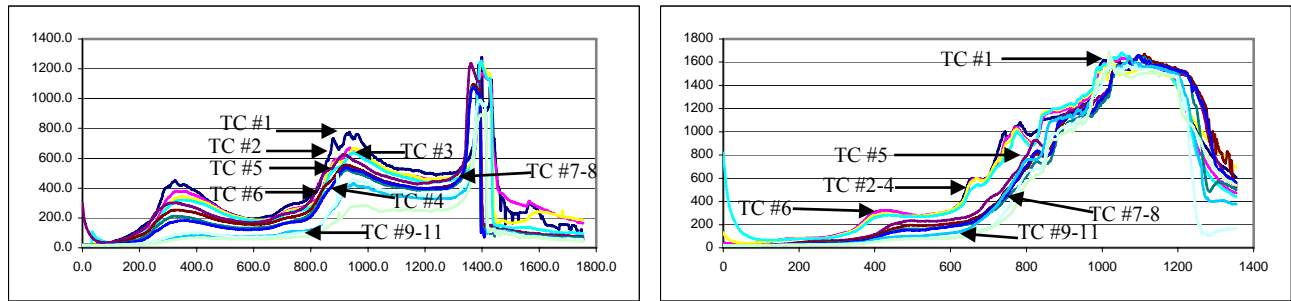
Figures 12 & 13 – Experiment Set “C” Thermocouple Data: (left)-Cell #1 (exp. 5); (right)-Cell #2 (exp. 6)

The test in cell #1 (experiment #5) was stopped early due to hazardous weather conditions creating an unsafe work environment. The temperatures measured by the thermocouple tree located in the bedroom of each experiment are shown in Figures 12 and 13. In experiment #5, the technical indicator for flashover of 600°C (1112°F) in the upper layer was achieved at approximately 1396s (seconds). However, the full transition of flashover into full-

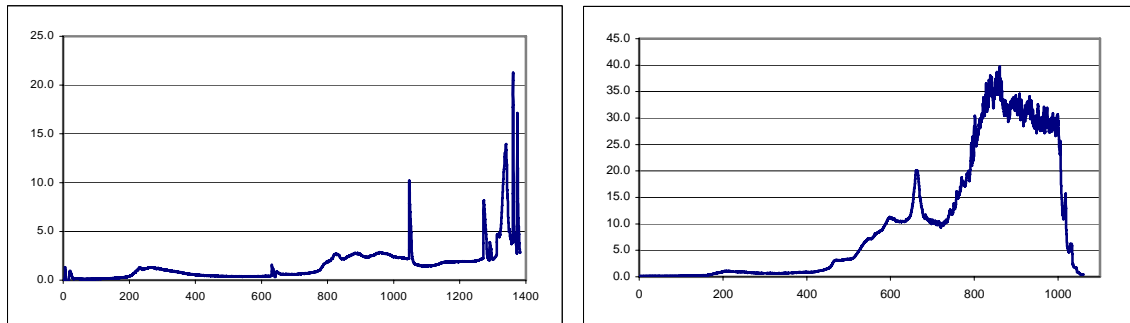
Figures 14 & 15 – Experiment Set “C” – Cell #1 (left) & Cell #2 (right) Radiometer Data

Additionally, experiment set "C" had a heat flux transducer placed in each cell. The radiant heat flux at the floor of the bedroom was measured with a water cooled, Schmidt-Boelter type heat flux transducer. The transducer was equipped with a Zinc Selenide (ZnSe) window to exclude convected heat flux. The view of the transducer, with the ZnSe window installed, was approximately 150°. The transducers were installed near the closet of each test cell.

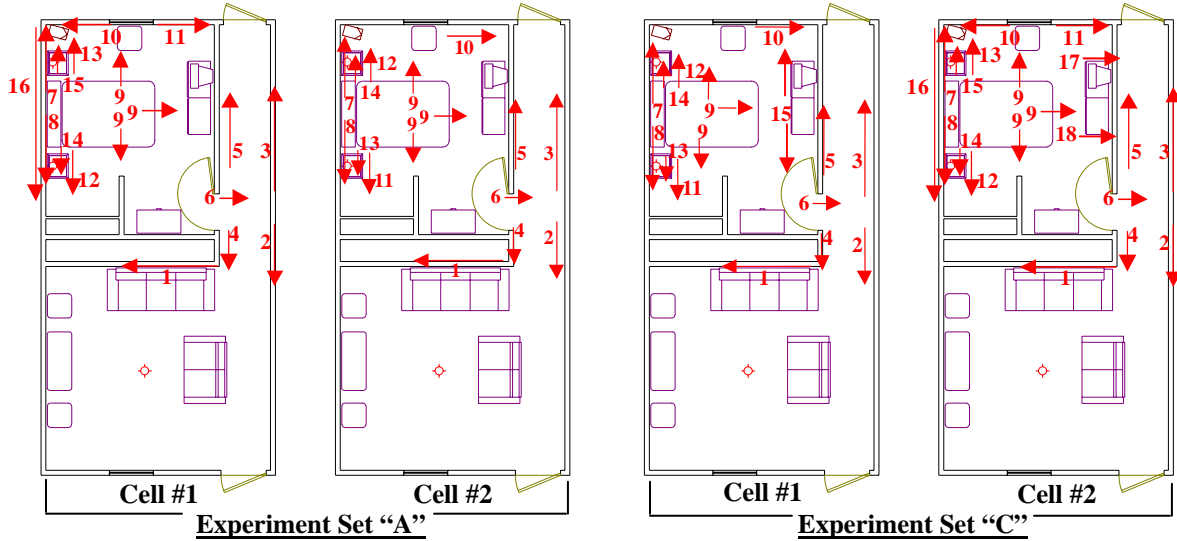
Figures 16-19 – Comparison of Heat and Flame Vector Diagrams
(left to right) Experiment Set “A”: Cell #1; Cell #2; Experiment Set “C”: Cell #1; Cell #2

Heat and Flame Vector Analysis: Each experiment was individually analyzed for all identifiable patterns. A heat and flame vector (arrow) was drawn on the respective diagram for each pattern to represent the direction of movement (fire spread). Experiment sets “A” and “C” were identical in furniture layout, and therefore, have been placed side-by-side for comparison purposes of their respective heat and flame vector diagrams (Figures 16-19). Experiment set “B” heat and flame vector diagrams are shown in Figures 20 and 21.

The Heat and Flame Vector diagrams for experiment sets “A” and “C” (experiments 1, 2, 5 and 6) demonstrate consistency. In fact, the first nine vectors for all four experiments show remarkable resemblance to each other and form the basis for the reliability of utilizing patterns and heat and flame vector diagrams for the accurate identification of an area of origin. Experiment set “B” (experiments 3 and 4) demonstrates even stronger consistency in vector analysis. Every pattern from experiment #3 was reproduced in experiment #4.

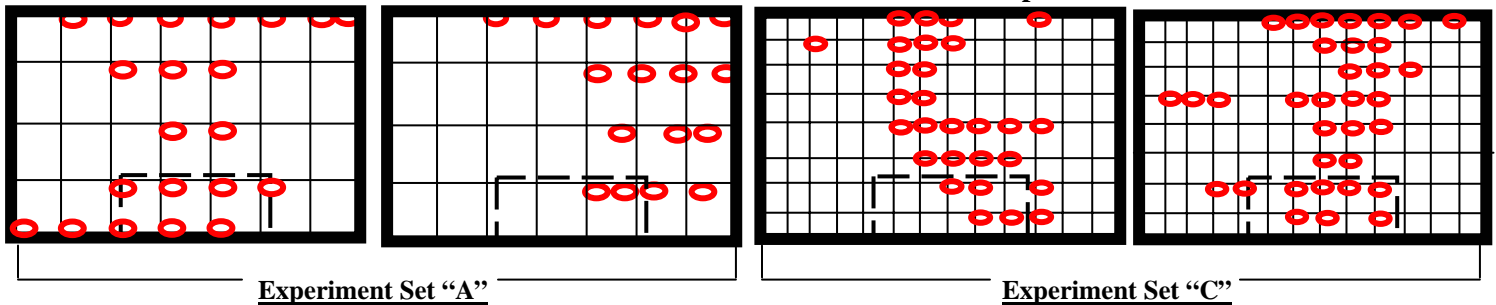
Figures 22-25 – Comparison of Depth of Calcination Elevation (East Wall) Diagrams
(left to right) Experiment Set “A”: Cell #1; Cell #2; Experiment Set “C”: Cell #1; Cell #2
Circles indicate a measurement of 1.5 mm or deeper

Depth of Calcination: Depth of calcination measurements were taken and recorded utilizing a depth gauge on a two-foot by two-foot grid for experiment set “A” and a one-foot by one-foot grid for experiment sets “B” and “C”. These depths of calcination readings have been transferred onto depth of calcination diagrams for additional pattern comparisons (Figures 22 and 27). Experiment sets “A” and “C” are illustrated by an elevation diagram of the east bedroom wall with the outline of the bed illustrated by a dashed line (Figures 22-25). A circle indicates a measurement of 1.5 mm or deeper, thus displaying a pattern of similar total heating. Experiment set “B” is demonstrated by an elevation diagram of the east wall with the outline of the couch illustrated by a dashed line (Figures 26 & 27). A circle indicates a measurement of 0.7 mm or deeper, thus displaying a pattern of similar total heating.

A review of the depth of calcination diagrams with the post-fire photographs illustrates similarities between the visible patterns that remain and the measured intensity patterns in and on the calcined wallboard. Though there are slight differences in the resemblance of the diagrams from different tests, a general consistency is demonstrated between all of them.

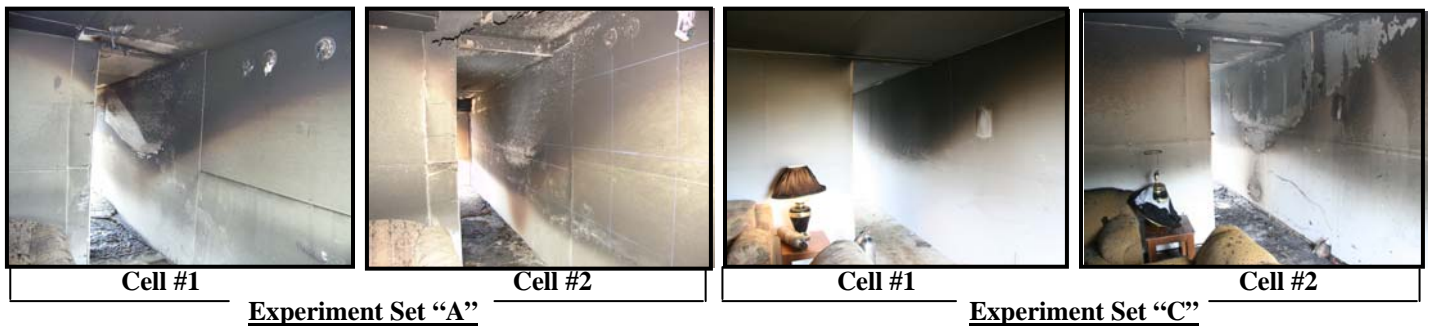
Figure 28-31 – Hallway (left to right) Exp. Set “A”: Cell #1, Cell #2; Exp. Set “C”: Cell #1, Cell #2

Similar truncated cone patterns (i.e. boundary patterns) were witnessed on the walls in all four experiments. The patterns remaining on the hallway walls demonstrate consistency. All four experiments produced a “U-shaped” pattern opposite the doorway on the hallway wall. The only difference that existed was the pattern in experiments #2 and #6 had a lower vertex than experiments #1 and #5 (Figures 28-31).

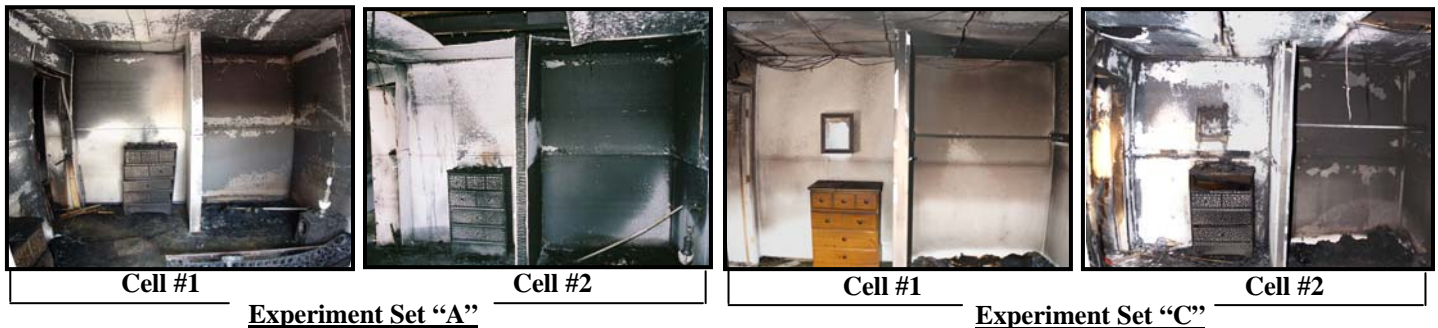
Figure 32-35 – North Wall (left to right) Exp. Set “A”: Cell #1, Cell #2; Exp. Set “C”: Cell #1, Cell #2

Along the north wall, a similar area of clean burn located on the west side above the chest was witnessed for the three experiments that progressed to full-room involvement (Figures 32, 33 and 35). Also, similar lines of demarcation are witnessed for all four experiments (Figures 32-35).

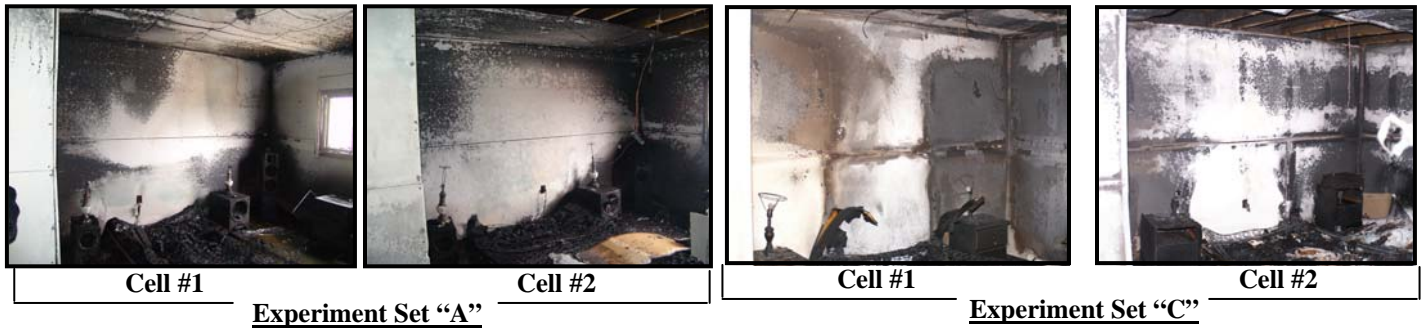
Figure 36-39 – East Wall (left to right) Exp. Set “A”: Cell #1, Cell #2; Exp. Set “C”: Cell #1, Cell #2

A consistency of the plume pattern on the east wall directly above the bed was witnessed for all four experiments. Additionally, a similar elongation of the plume pattern toward the south wall, where the window was located, was witnessed in all four experiments (Figures 36-39).

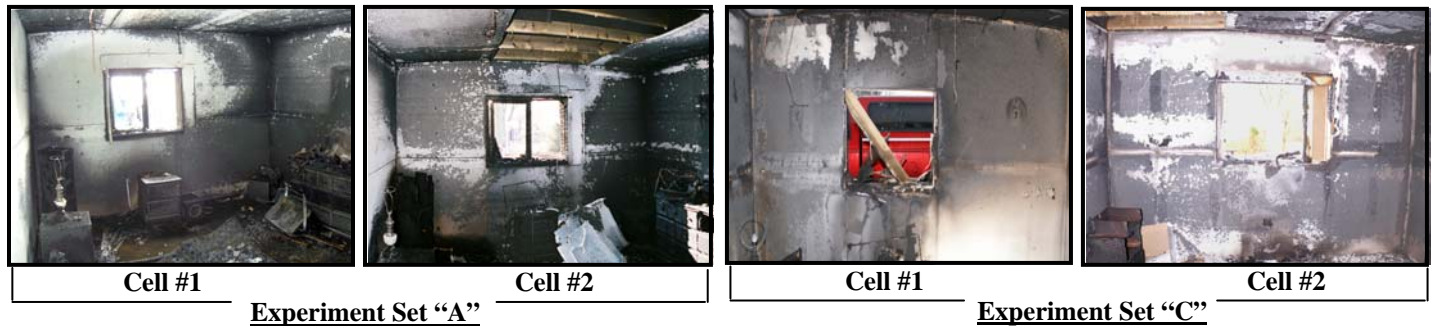
Figure 40-43 – South Wall (left to right) Exp. Set “A”: Cell #1, Cell #2; Exp. Set “C”: Cell #1, Cell #2

The plume pattern on the east wall also extended onto the south wall with an area of greater damage (clean burn) for all four experiments witnessed near the ceiling of each wall and the window. Additionally, a “U-Shaped” pattern was witnessed along the south wall for all four experiments that corresponded with the truncated cone of the plume originating from the bed (Figures 40-43).

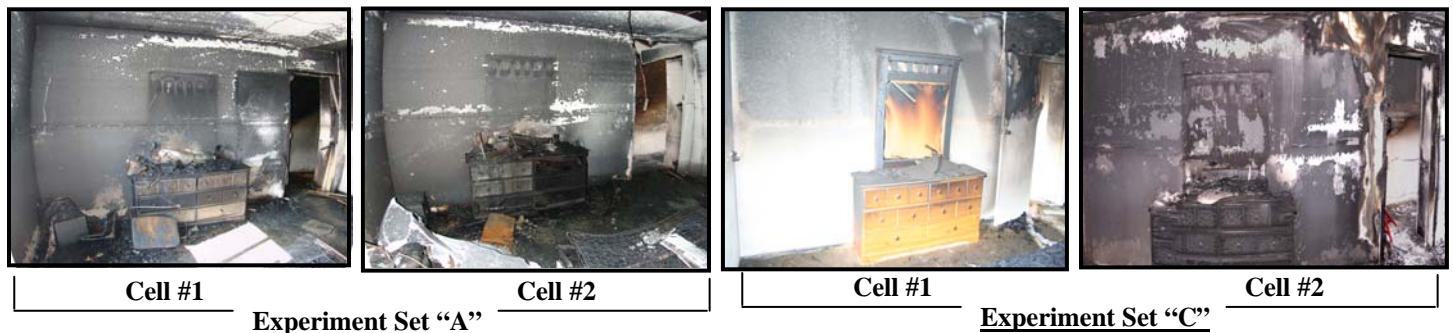
Figure 44-47 – West Wall (left to right) Exp. Set “A”: Cell #1, Cell #2; Exp. Set “C”: Cell #1, Cell #2

The patterns remaining on the west wall of the bedroom in all four experiments show good consistency (Figures 44-47). For example, protected area patterns remain on the west wall in the pre-fire location of the door and mirror for all four experiments.

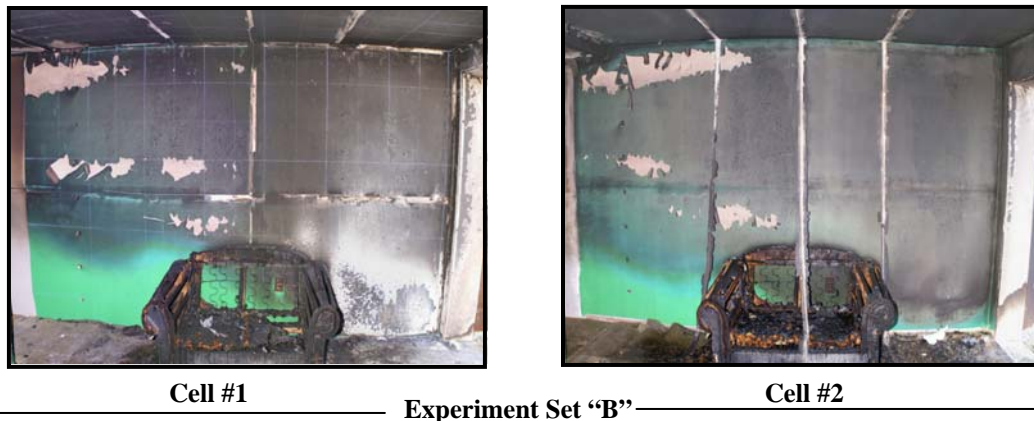
Figure 48-49 – Experiment Set “B”: West Wall - Cell #1 (left); Cell #2 (right)

Experiment set “B” (experiments #3 and #4) demonstrated remarkable similarity of the fire patterns. The loss of material patterns for the couch, loveseat, and end tables were almost identical (Figures 48-55). The ventilation patterns near the doorway were similar (Figures 48 and 49). The demarcation lines on the west wall corresponding to the airflow over the loveseat were nearly exact (Figures 48 and 49).

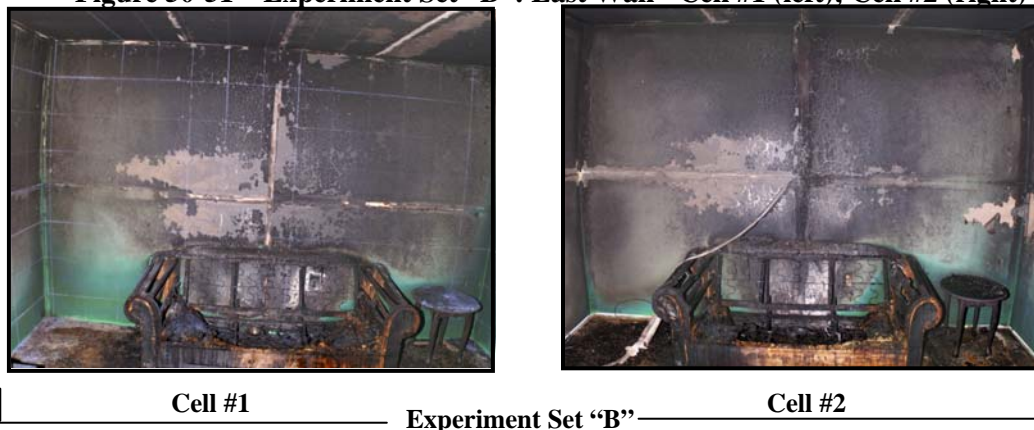
Figure 50-51 – Experiment Set “B”: East Wall - Cell #1 (left); Cell #2 (right)

Located on the east wall above the couch, a conical-shaped plume pattern existed in almost exact appearance between the two experiments (Figures 50 and 51). In fact, an almost perfect reproduction of the area of clean burn remained on each wall behind the couch.

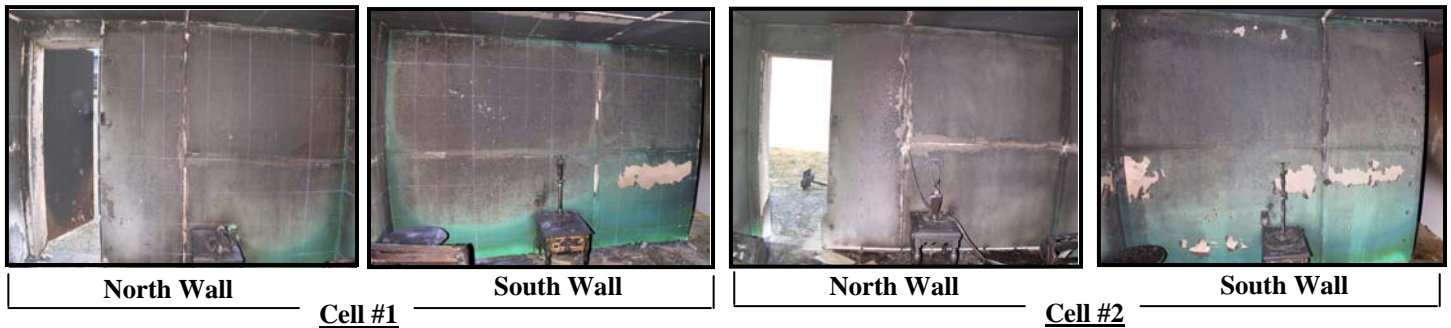
Figure 52-55 – Experiment Set “B”: (left to right) Cell #1; Cell #2

The remaining walls had similar truncated cone patterns, which originated from the plume on the couch (Figures 52-55).
